Re: Request for Minor Modification for Partial Removal  
of Surface Pillar for the Cowboy-Bandana Mine Plan  
at Gilsonite Lease U-0122693

ENCLOSURE #1  
to BLM MARCH 19, 1997 LETTER

# PLOT PLAN

*COWBOY VEIN GILSONITE MINES*

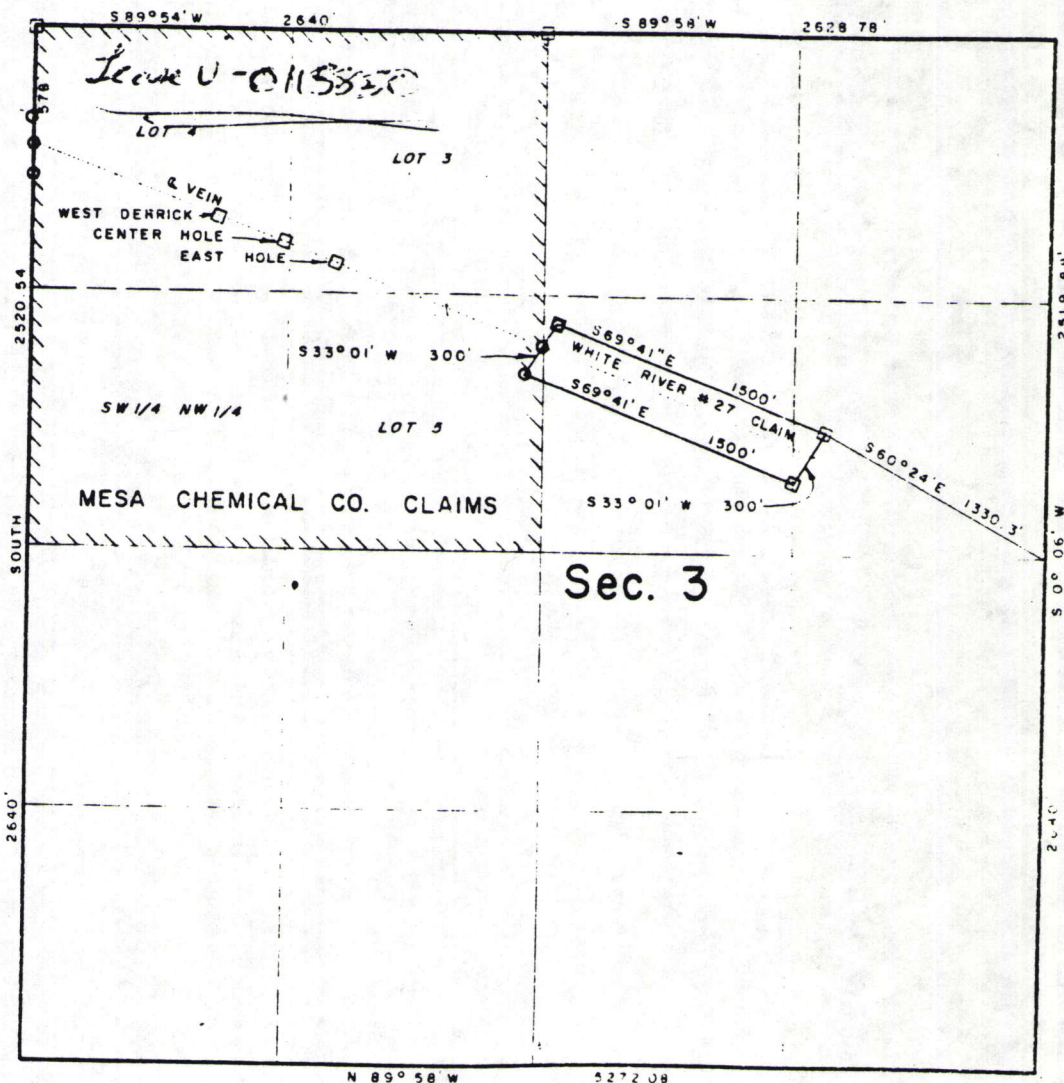
1. Backfill and seal with a concrete slab the area that has caved (Attachment A).
2. Fence and post with signs, warning the public of danger, the undermined area between the caved area and shaft number C-3 (Attachment A).
3. Shafts, escapeways, and subsidence areas will be fenced adequately and posted with signs informing the public of the existence of a dangerous area. These areas should be checked on a monthly basis to see that the openings remain closed and the fence intact.
4. Debris, presently scattered around the mine areas, is to be cleaned up and disposed of at the Vernal City dump.
5. Surface areas, that have been disturbed, are to be graded as near as practical to existing topographic contours occurring in the area.
6. Type, method, and scheduling of revegetation will be specified by the appropriate surface management agency.

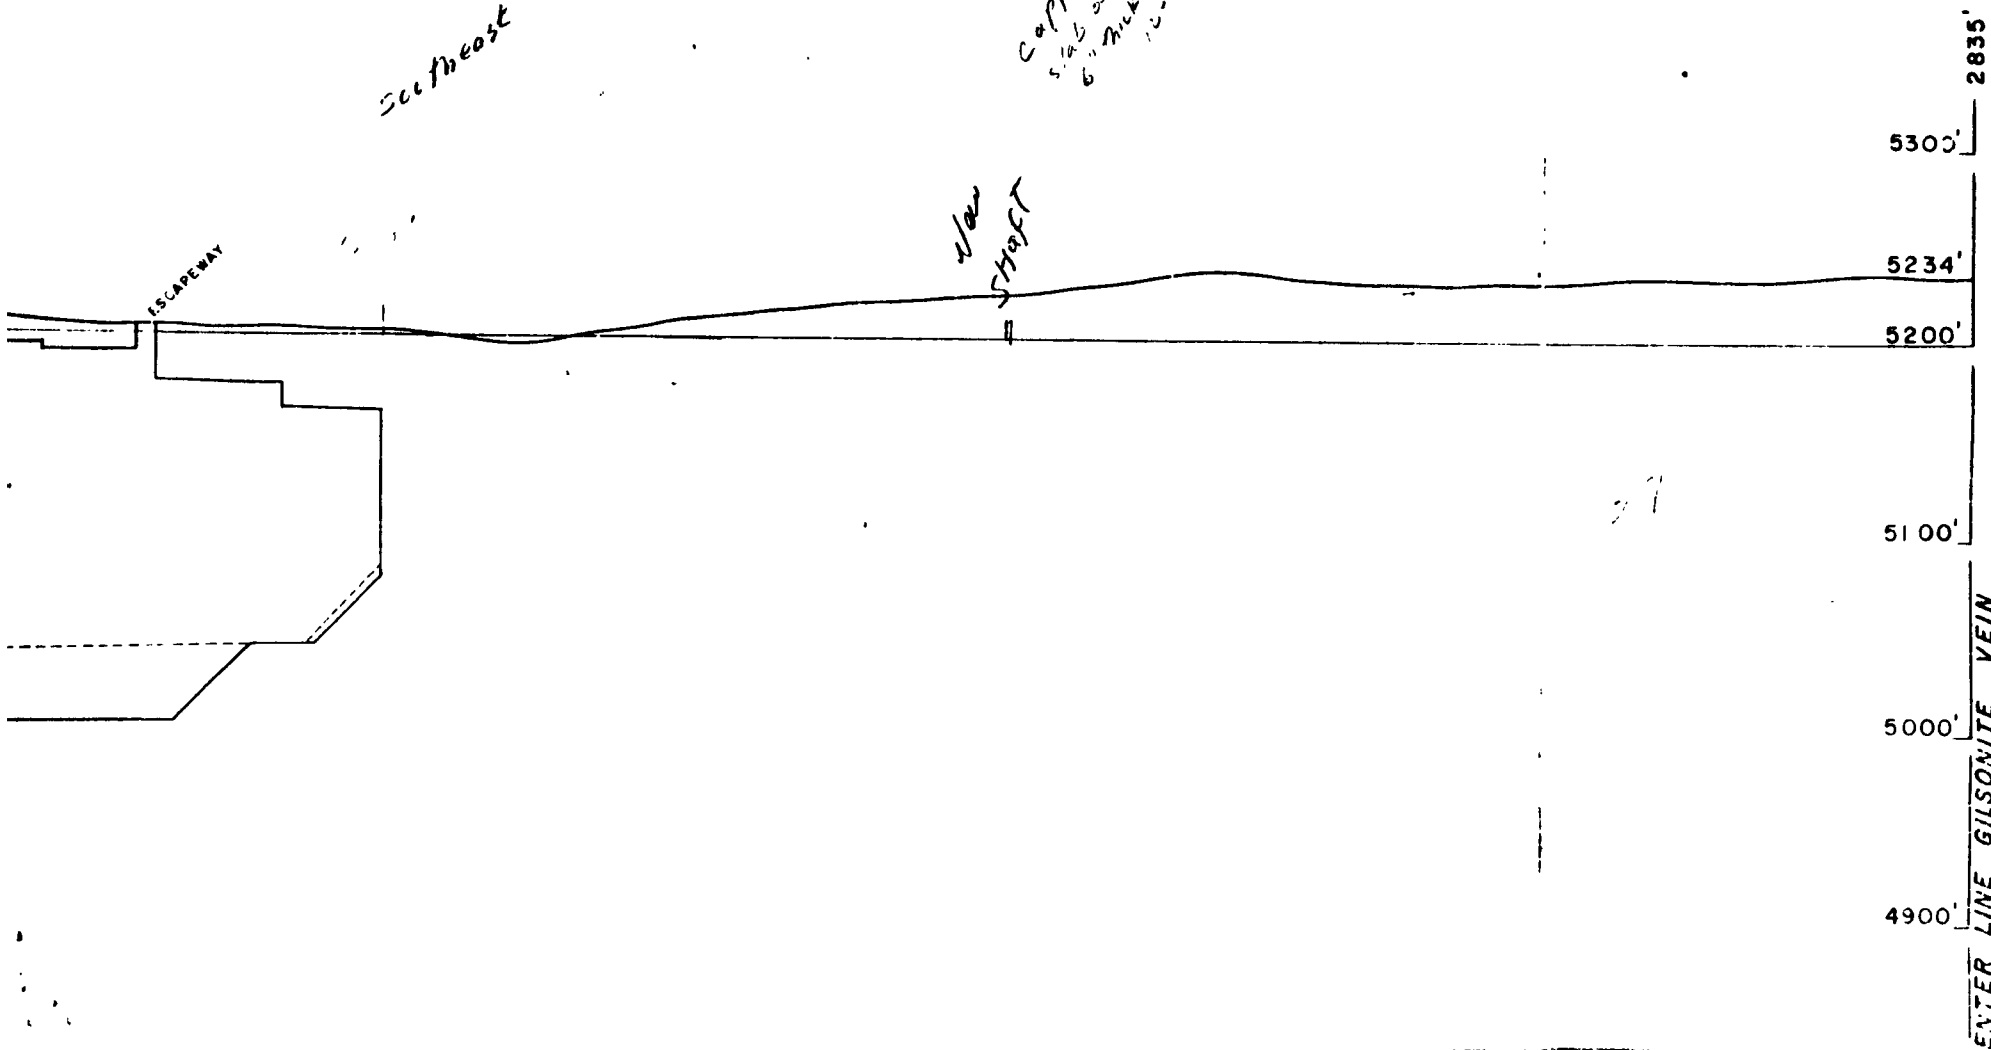
*New  
Shaft*

*Capped w/ conc.  
slab out to it  
6" thick as shown  
12-9-74*
